# Sediment Impact Assessments for the Rio Guanajibo at Mayaguez and San German, Puerto Rico

by William A. Thomas

Final report

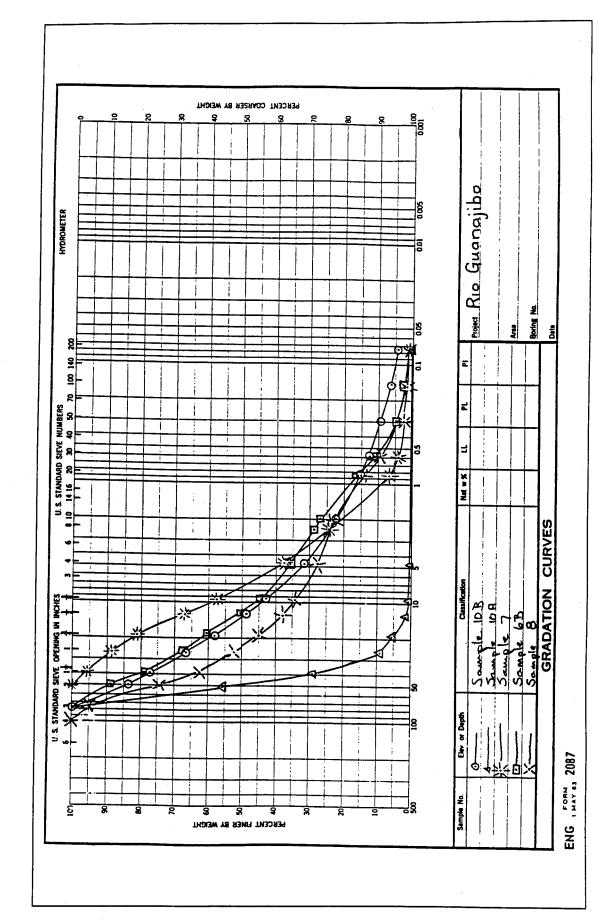
Figure 3. Bed sediment gradation curves, San German Project Reach

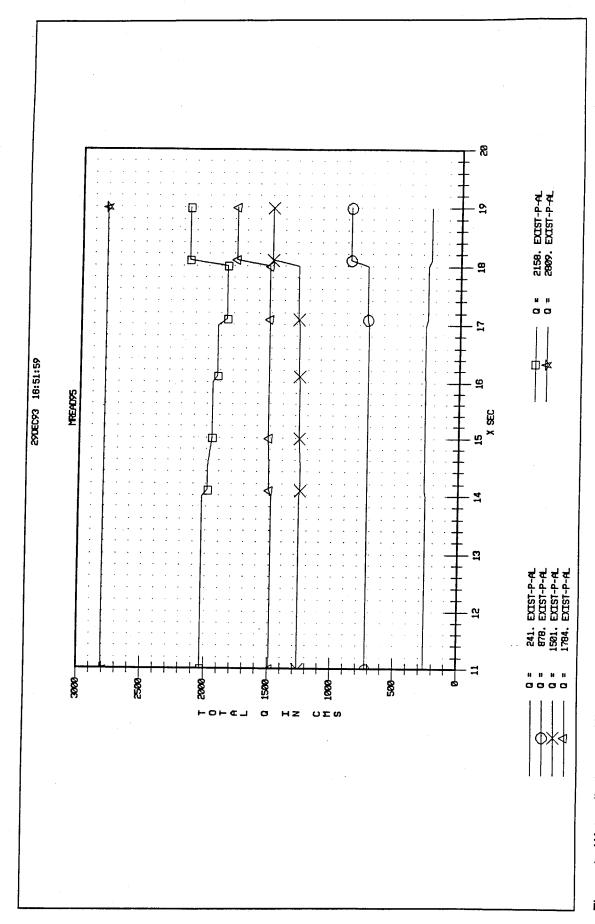
Figure 4. Water discharges, HEC2 model of existing channel, San German Project Reach

The basis for these average hydraulic parameters is shown in Figures 4 through 11. Figure 4 shows how the water discharge varies within the HEC2 data set. These water discharges are plotted versus cross section numbers from

the HEC2 geometry, and in this case they span the entire HEC2 model. The project reach begins at "X SEC 15.1" on the abscissa and extends up to cross section number 13.

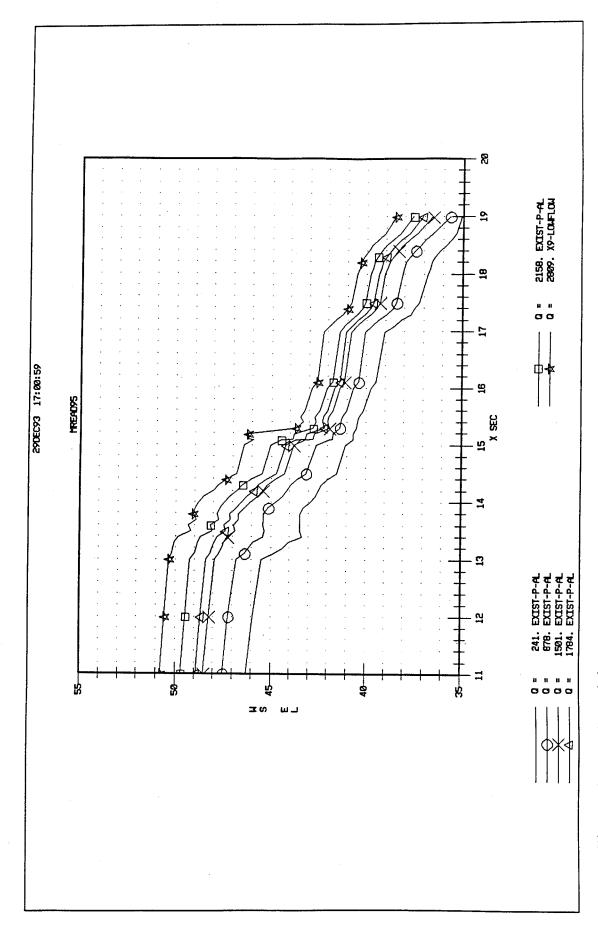
Figure 5. Water surface profiles, existing conditions, San German Project Reach

Figure 5 is the HEC2 water surface profiles for these discharges. Notice the legend keys on water discharge. In this case, it is the same as Figure 4. In the general case, the water discharge at the downstream end of the averaging reach is used in the legend to reference the plot. Figure 4 profiles provide that water discharge at each cross section. It can be used to define the legend for profiles through any portion of this Tape95 data set. Figure 5 shows calculated water surface profiles for these flows.

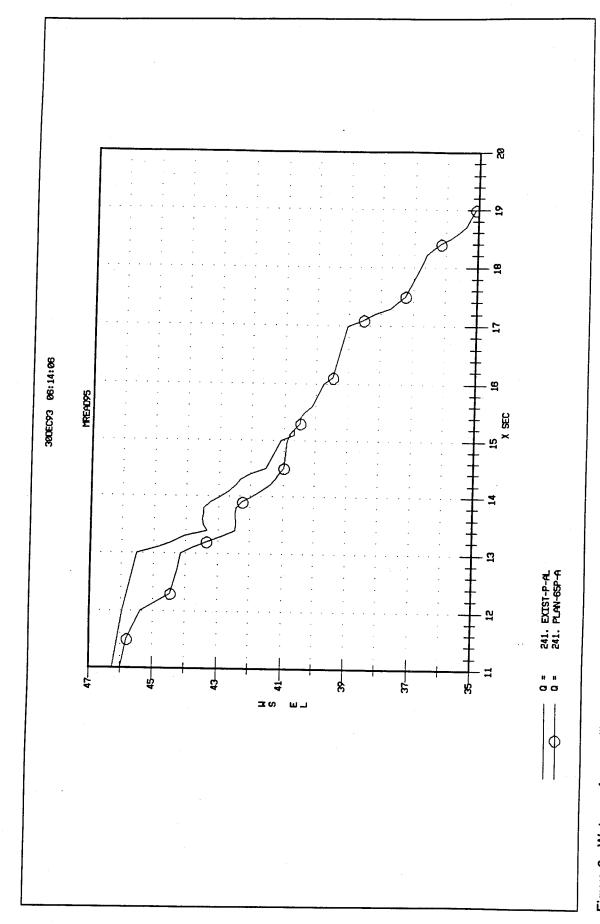
Figure 6. Water surface profiles, existing and project conditions, 2-yr flood peak, San German Project Reach

Figure 6 is the HEC2 water surface profile for the 2-yr flood for existing and project conditions. It shows the slope change in the project reach as well as the convergence of profiles upstream from the project reach. The channel over which the profiles return to preproject conditions is referred to as the "approach channel" in ER 1110-2-1405. That convergence is not yet complete in Figure 6 which indicates some additional design work is needed on the approach channel.

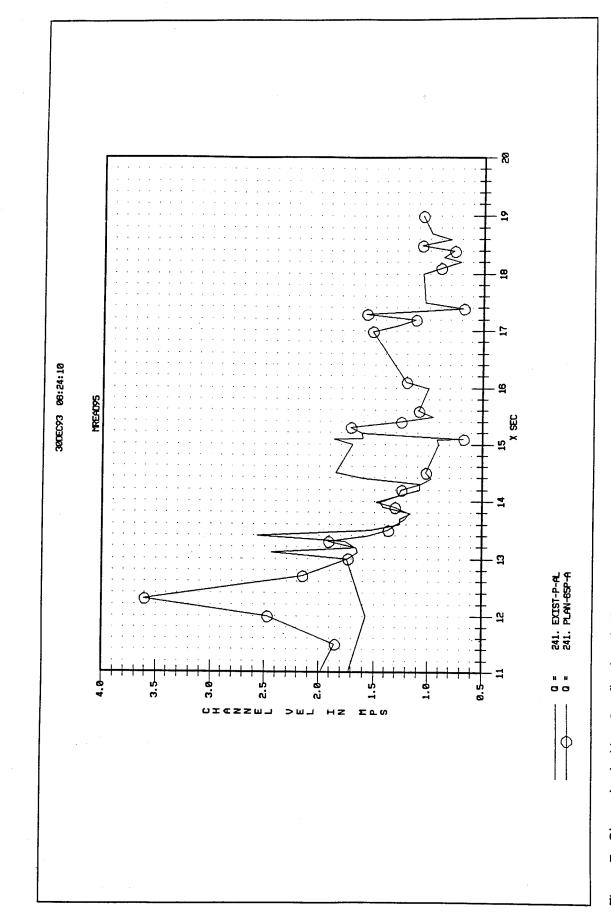
Figure 7. Channel velocities, 2-yr flood peak, San German Project Reach

Figure 7 shows the channel velocities. They fluctuate through the project reach, but there is no trend in the existing channel. The average value will be used to test channel stability.

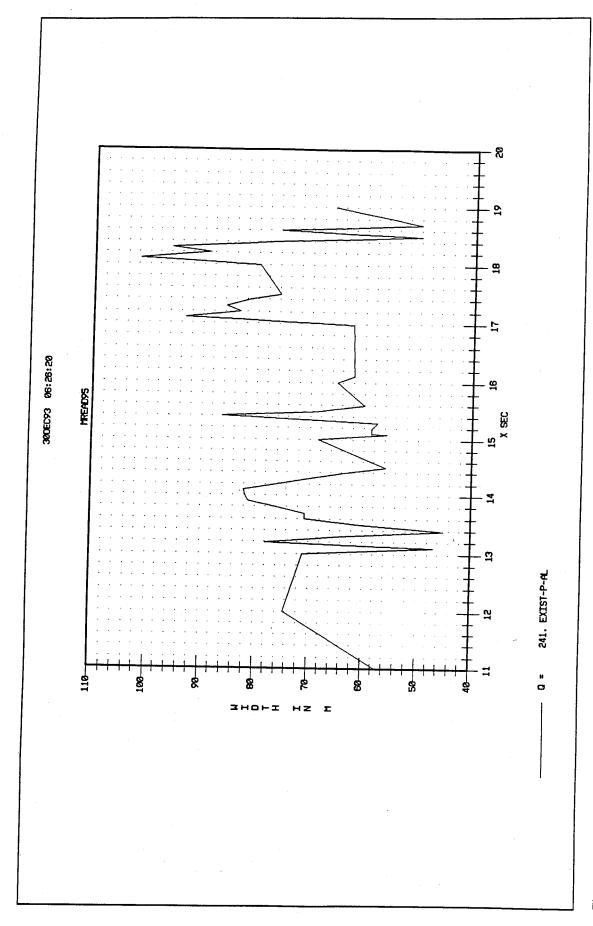
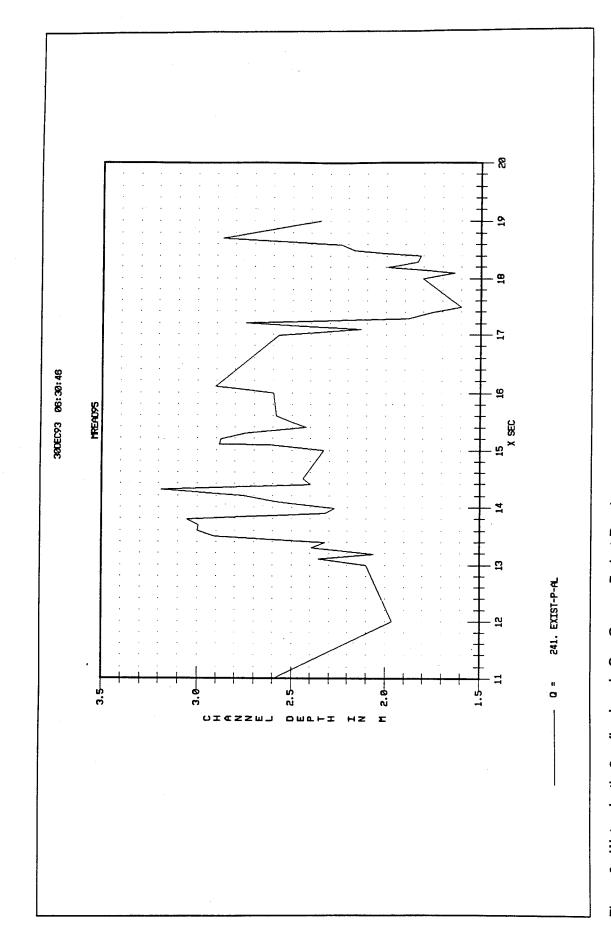
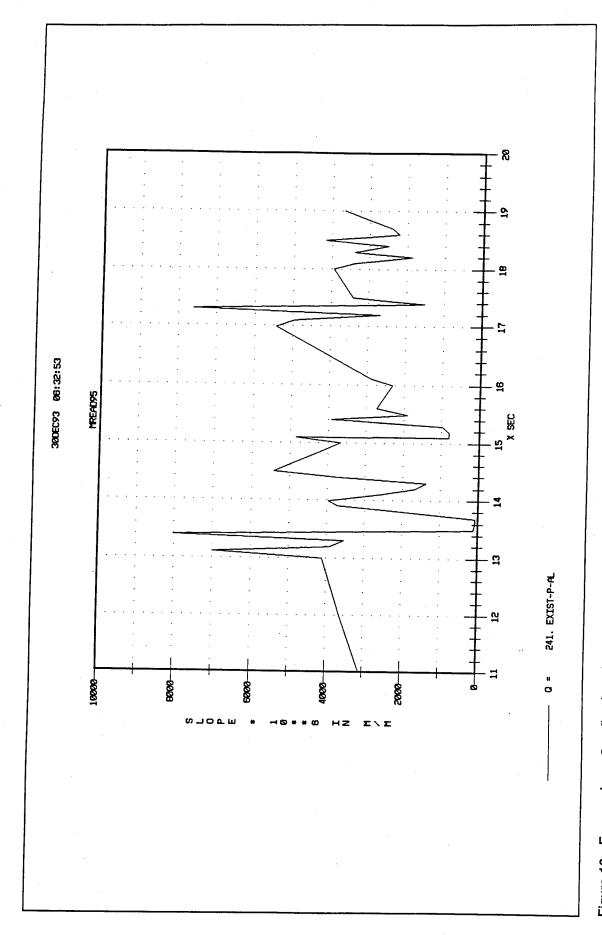
Figure 8. Water surface width, 2-yr flood peak, San German Project Reach

Figure 9. Water depth, 2-yr flood peak, San German Project Reach

Figure 10. Energy slope, 2-yr flood peak, San German Project Reach

Figures 8, 9 and 10 are the hydraulic geometry parameters. The width and depth fluctuations are fairly common. The slope profile shows calculated values and not bottom slope. The average values will be compared with hydraulic geometry relationships.

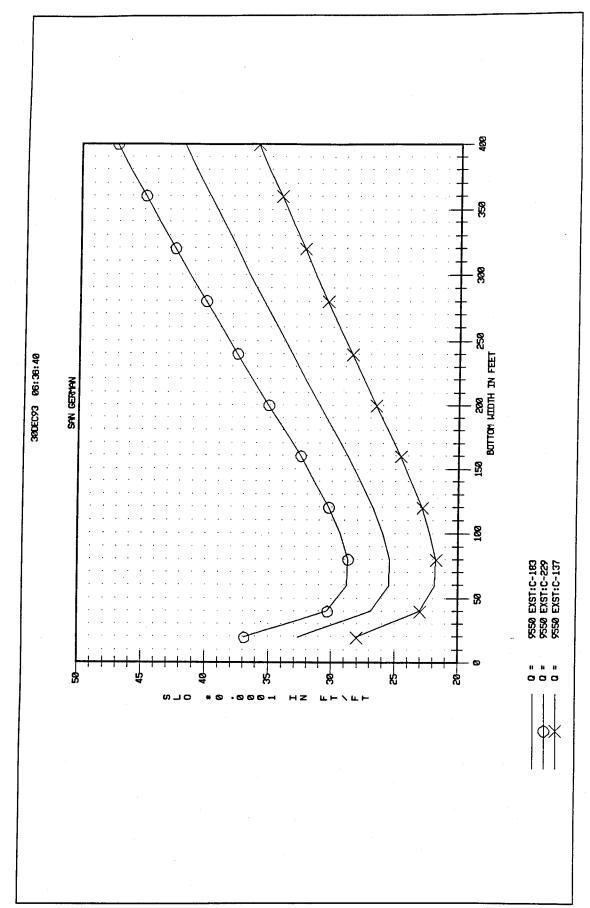
Figure 12. Calculated channel width and slope for existing conditions, stable channel analytical method, San German Project Reach

Channel Stability Based on the Analytical Method. Figure 12 shows the calculated width-slope relationship from existing channel conditions. (Note: This calculation is available only in English units.) The inflowing sediment concentration, i.e. the bed material load entering the project reach, was calculated from a supply reach. For that calculation, the channel hydraulic properties from Table 2 were used to develop one representative trapezoid. The top width of that trapezoid is 220 feet (67.04 m) and the depth is 8 feet (2.51 m). The channel was given side slopes of 1V:2H which resulted in a bottom width of 190 feet (57.91 m). The effective bank roughness was assigned a value of 4 feet and Manning's n-value for the bank was calculated, by Strickler's Equation, to be 0.043. The Brownlie bed roughness predictor was used to calculate the bed n-value.

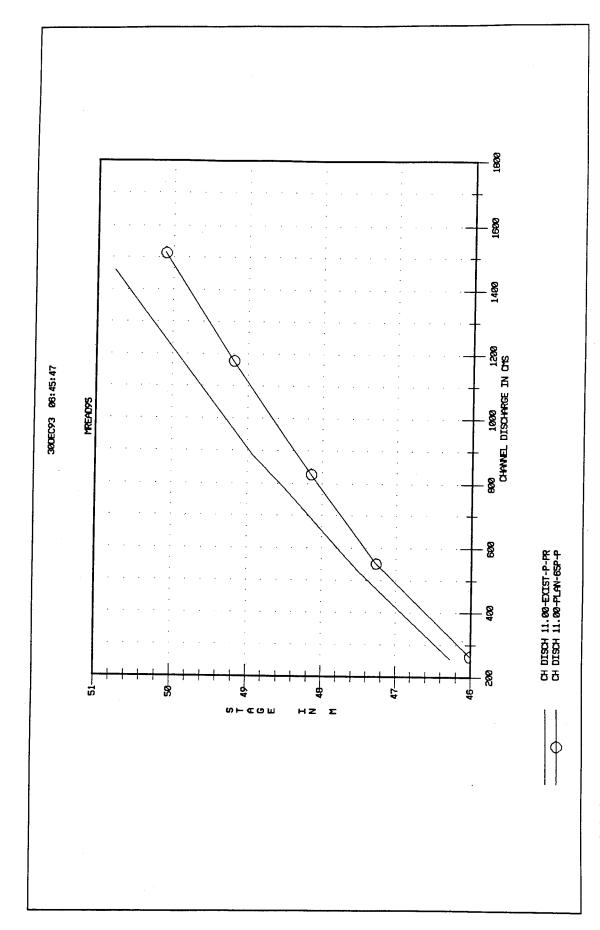
Figure 15. Calculated stage-discharge relationship, approach channel, San German Project Reach

The approach channel is that reach of river upstream from the project reach over which the energy gradient returns to preproject conditions. Figure 15 shows the calculated stage-discharge rating curve at cross section 13. The with-project stage is from 0.3 to 0.8 m lower than preproject conditions which indicates the approach channel should extend further upstream. Figure 16 is another way to view the project impact on the energy gradient. It shows project velocities to be as much as 0.5 m/s faster than preproject velocities were at this section. In the design phase more attention needs to be given to the approach reach.

The calculated stage-discharge rating curve at cross section 13 is from 0.3 to 0.8 m lower than preproject conditions which indicates some additional work is needed to design the approach channel. That is a detail which can be handled in the next phase of project development. Some maintenance in the exit channel is likely immediately after the project goes into operation, but the reach of river which is the exit channel to this project is expected to function as it did historically.

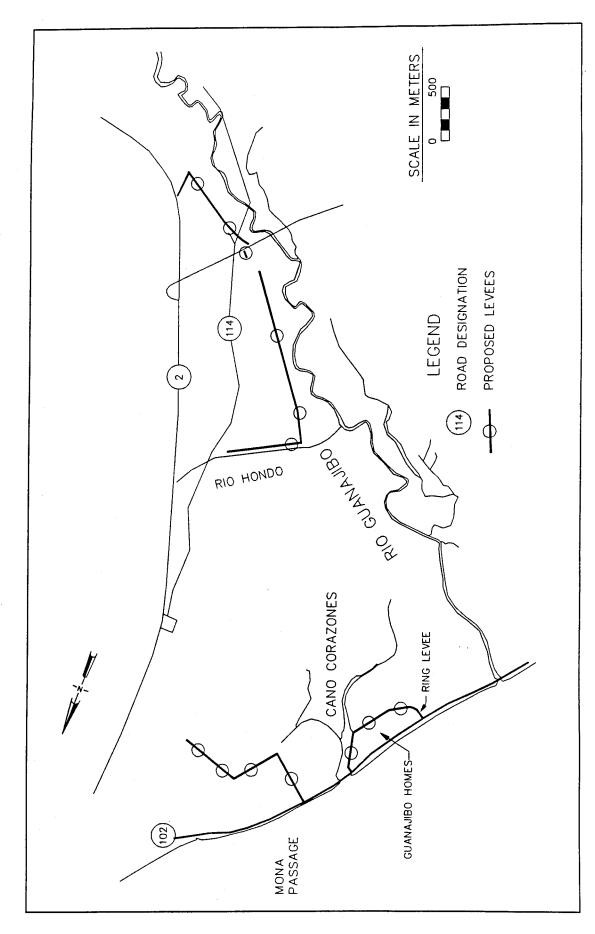
Figure 17. Project map, Mayaguez-Hormigueros Project Reach

The Mayaguez-Hormigueros flood protection project extends inland from the coastline for about 8.6 km, as measured along the channel. This project will consist of three levees, Figure 17. No channel modification will be made. The bed material at this site is sand and gravel. The hydraulic-sediment analysis of this project is complicated by the proposed ring levee around Guanajibo Homes because that levee creates a divided-flow condition. Part of the discharge passes out the main outlet of the Guanajibo River and the rest flows out through the Cano Corazones channel.

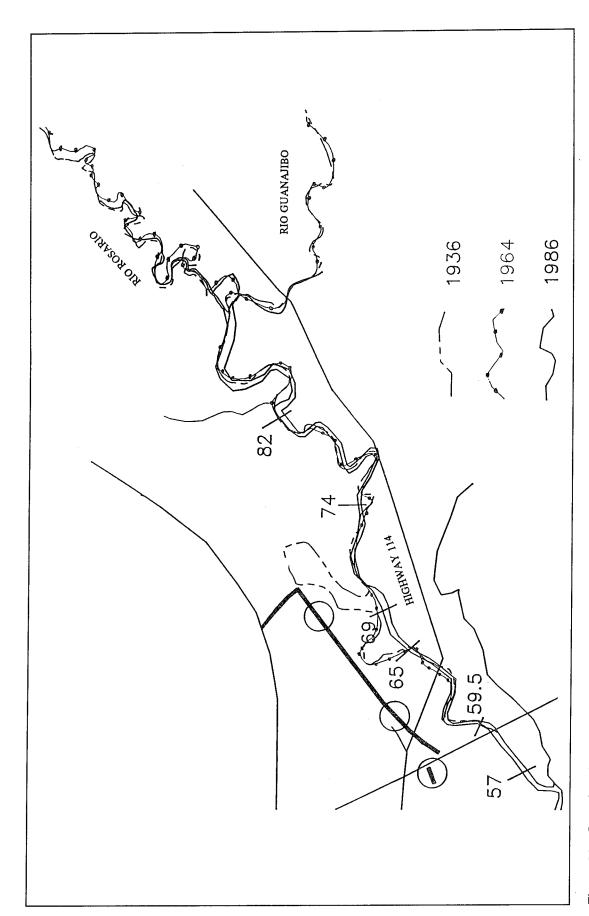
Figure 30. Overplot of 1936, 1964, and 1986 channels, confluence of Rio Rosario and Guanajibo

For example, the first observation is based on aerial photography. Such a high deposition rate would cause lateral migration of the channel as well as aggradation of the adjacent flood plain. In an effort to confirm that process, aerial photographs were obtained from the Corps of Engineers Project Office in Puerto Rico. Figures 27, 28 and 29 show the Guanajibo/Rosario confluence taken in 1936, 1963 and 1983, respectively. Figure 30 is an overplot of the channel from the 1936 aerial photo, the 1964 USGS Quadrangle (Mayaguez, P.R.) and the Corps of Engineers project survey map dated 1986. Whereas there are major channel changes at cross sections 65 and 69, telephone conversations with Mr. Roberto Cortes Colon' of the Corps of Engineers Project Office, Puerto Rico, indicated those were man made cutoffs. The overplot shows a high degree of lateral stability of the channel over that 50-year period. That does not support the trap efficiency calculation.
